**Traditional Reserve Study  
For  
Willow Wood Village Homeowners Association, Inc.  
Dunedin, Florida  
August 7, 2026**

**Report Number: 2026.08.07.504**

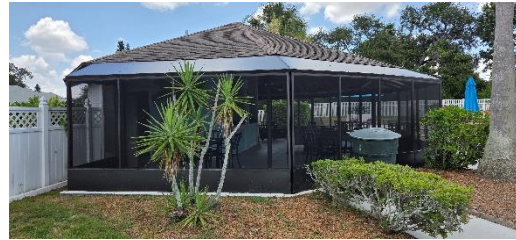
**Item Description:**  
Cabana Roof

- **Cabana Roof, Asphalt Shingle** – There are approximately 2 squares of asphalt shingles for the cabana roof. Fair condition.
- **Cabana Screen Enclosure** – There is approximately 75 linear feet of screen enclosure area. Great condition, all screen and metal work recently redone.

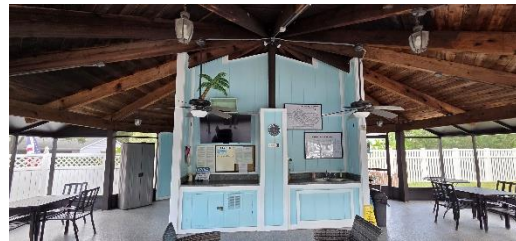
**Item Description:**  
Painting and Waterproofing

- **Cabana Furniture and Décor** – Furniture and decor in the cabana area. Fair condition.
- **Cabana Painting and Waterproofing** – There is approximately 650 square feet of painting and waterproofing at the cabana area. Good condition, recently repainted.

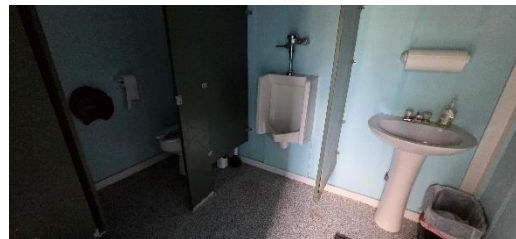
**Item Description:**  
Bathrooms

- **Cabana Bathrooms** – There are 2 bathrooms at the cabana. Fair condition.
- **Cabana Flooring** – There is approximately 700 square feet of concrete skim coat flooring in the cabana area. Great condition, recently refinished.

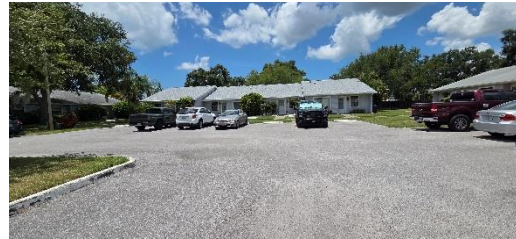
**Item Description:**  
Asphalt Mill and Overlay

- **Asphalt Pavement, Mill and Overlay** – There is approximately 9,900 square yards of asphalt roads. Appears to be in fair condition.
- **Asphalt Pavement, Seal and Coat** – There is approximately 9,900 square yards of asphalt roads. Appears to be in fair condition. Seal and coat have been applied several years ago to extend the useful life of the roads.

The Association may be able to mill and overlay the asphalt pavement prior to replacement. Milling and overlaying asphalt pavement is significantly less expensive than replacement, with approximately the same useful life if the asphalt pavement is maintained properly.

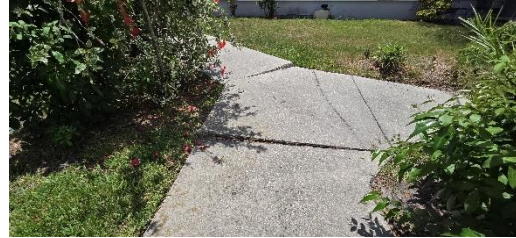
Concrete Sidewalk and Walkways

- **Concrete Sidewalks** – Concrete sidewalks and walkways for all common areas. Good condition with areas of repair and replacement.
- **Fencing, Wood** – There is approximately 1,220 linear feet of wooden property line privacy fencing. Good to fair condition.

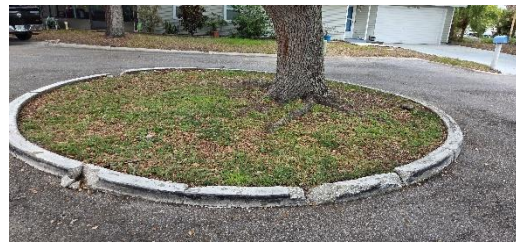
Concrete Curbs

- **Concrete Curbs** – Concrete curbs used to direct water off the roads and into storm drains. Good condition, aside from the curbs in the cul-de-sac's, poor condition.

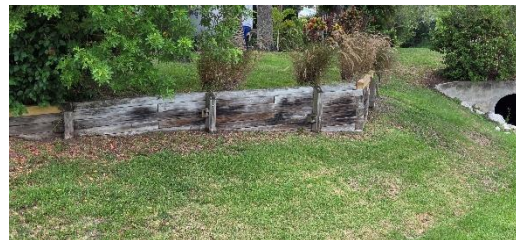
Bulkhead / Retaining Wall

- **Retaining Walls** – Wood retaining walls built around homes backing up to the creek running through the property. Fair condition, with some areas of replacement noted.

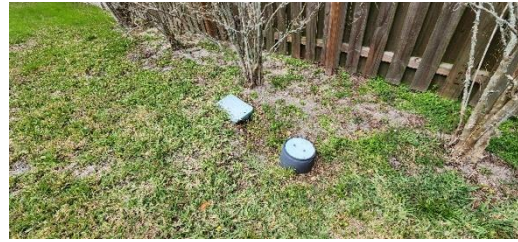
Irrigation System, Controls and Timers

- **Irrigation System, Controls and Timers** – New irrigation controls, timers and lines are being ran throughout the community. Good condition.
- **Monument Signs** – There are 2 monument signs at each entrance of the community. Great condition recently replaced.

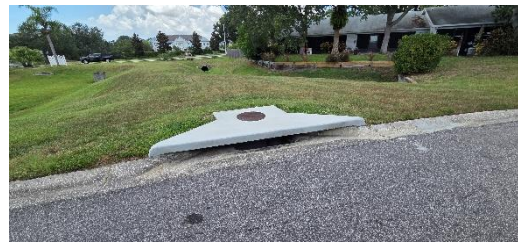
- **Backflow Preventor** – Backflow preventor helps maintain water pressure and keep water from flowing back to supply side. Average condition.
- **Catch Basins** – Drainage allowance for new drain locations and repairs of old drainage areas. Good to fair condition.

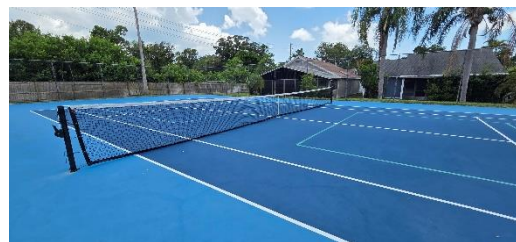
**Item Description:**  
Tennis Court Resurfacing

- **Tennis Court, Resurfacing** – Tennis courts recently resurfaced in 2023. Average condition with areas of organic growth coming through settlement cracks.

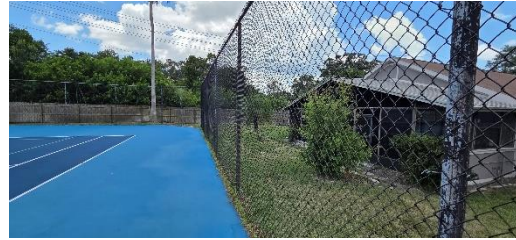
**Item Description:**  
Tennis Court Fencing

- **Tennis Court Fencing, Chain Link** – Tennis court fencing 10' galvanized chain link. Fair condition for age.
- **Tennis Court, Rebuild** – The tennis court is original but is in very good condition for its age.

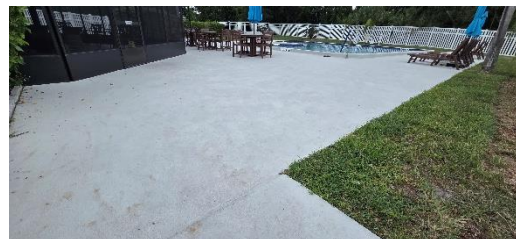
**Item Description:**  
Pool Decking, Resurfacing and Repairs

- **Pool Decking, Resurfacing and Repairs** – Pool decking for around the pool area. Great condition as the pool decking was recently refinished.
- **Pool Fencing** – 340 linear feet of vinyl fencing used to closed off the pool and cabana area. Average condition.
- **Pool Lining and Resurfacing** – Pool lining is used to keep a water-tight seal and improve the look of the pool. Good condition as seen from the waterline and the pool was refinished in 2018.
- **Pool Pumps, Electrical and Plumbing System** – This is the entire pool pump system including the electrical and plumbing system. Average condition with maintenance and repairs completed as needed.
- **Pool Furniture** – This is for the composite pool area furniture. Good condition.

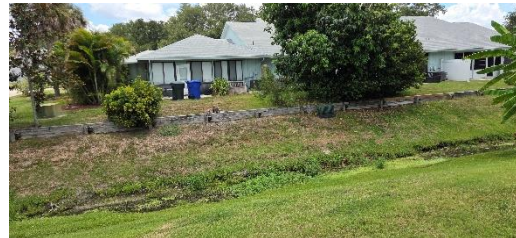
**Item Description:**  
Erosion Control

- **Erosion Control, Phase II** – This is for the erosion control remediation of the storm water drainage system that run along the south portion of the property. This project is going to be phase rebuilt at the direction of the board. No condition assessment.
